SECTION 32 PROGRAM
STREAMBANK EROSION CONTROL
EVALUATION AND DEMONSTRATION
WORK UNIT 2-EVALUATION OF EXISTING
BANK PROTECTION

FIELD INSPECTION OF SITES IN THE VICKSBURG DISTRICT
IN THE UPPER YAZOO BASIN

Malcolm P. Keown, E. A. Dardeau, Jr.

October 1978

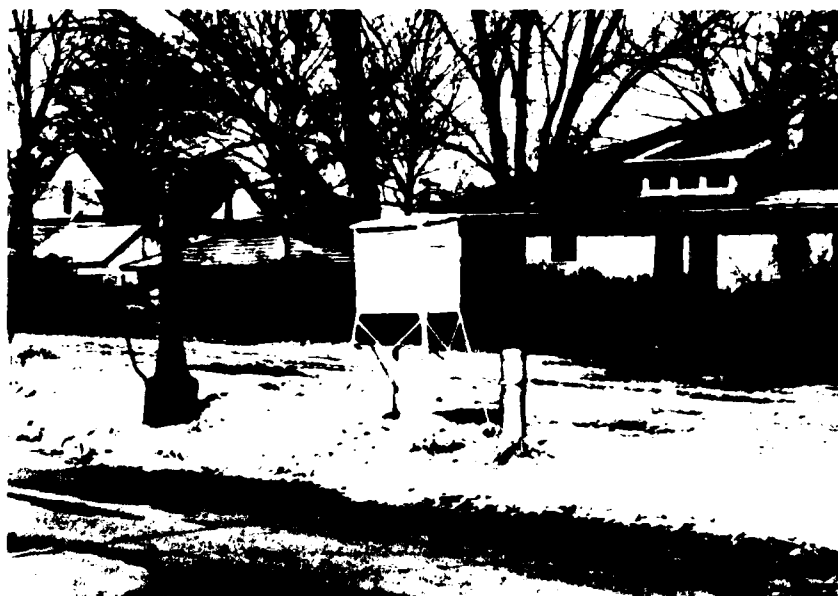
Figure 2. Meteorological station at Charleston, Mississippi (24 January 1978)

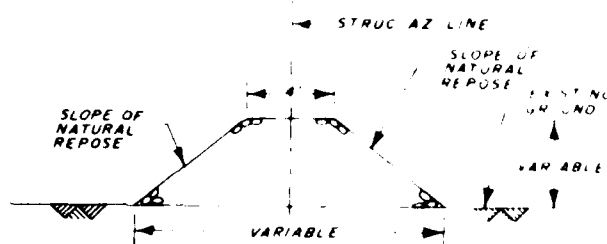
Figure 11. Lateral view of typical transverse dike (Source: Bank Stabilization, South Fork, Tillatoba Creek, Drawing No. 2, LMK, 1971)

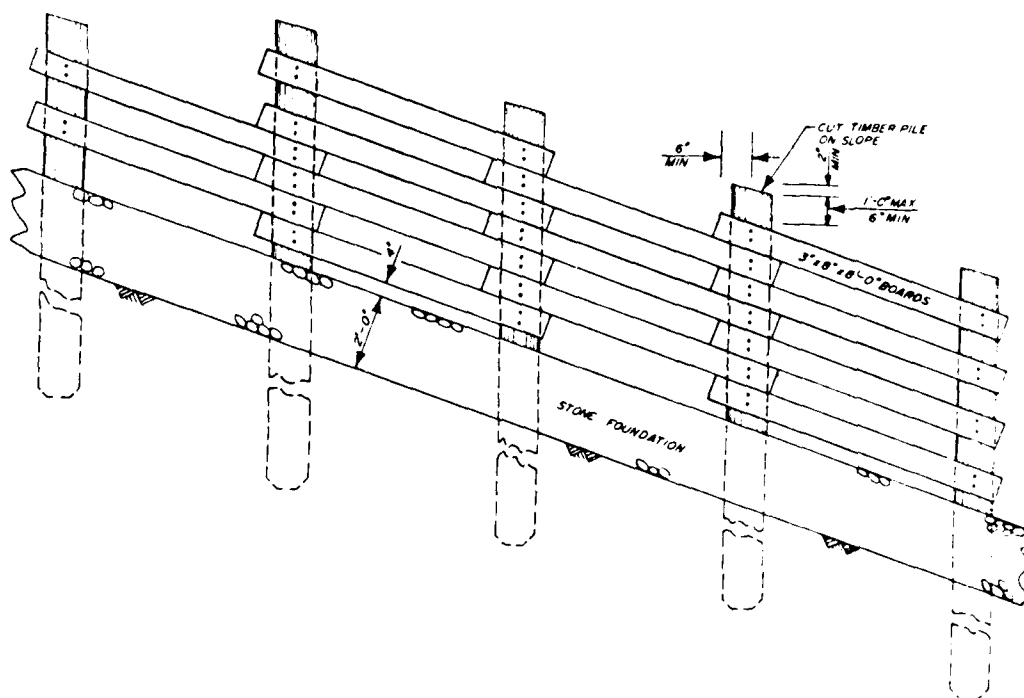
11. Board-fence dikes are a variation of the permeable jetty principle, i.e. reducing the water velocity such that sediment is deposited between the fences and the erosive currents of the stream are deflected by the fences away from the bank under attack (Figure 16). The board-fence dikes were constructed using 12-in.-diam (minimum) treated pilings and 3- by 8-in. treated boards 8 ft in length (Figures 17 and 18). The toe of the dikes was protected by placing a 0.5-ton/linear foot stone base, thus reducing flow concentrations and turbulence that would otherwise scour around the pilings. Flanking and runaround were prevented by placing a stone dike head at the point where each dike was tied into the top bank. The board-fence dikes have been successful in encouraging sediment deposition and in accumulating debris. During the 12 October 1977 inspection, it was noted that one of these structures had failed due to heavy drift flow during high flows (Figure 19).

Figure 17. Longitudinal view of a board-fence dike
(Source: Bank Stabilization, South Fork, Tillatoba
Creek, Drawing No. 4, LMK, 1972)

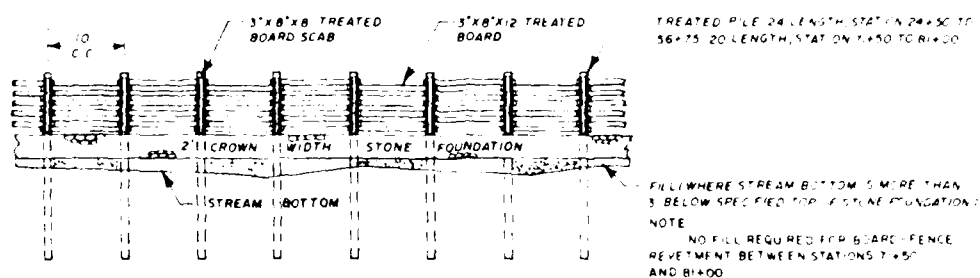
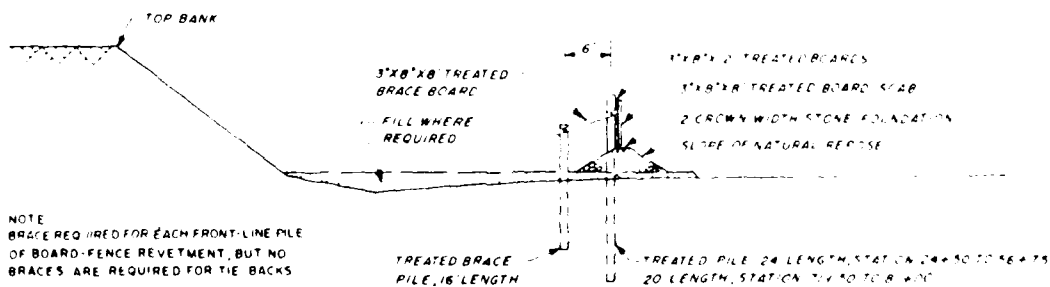
Figure 59. Board-fence revetment construction details (Source: Bank Stabilization, Batupan Bogue, Drawing No. 4, LTR, 1973)

31. The board-fence revetment was constructed using 12-in.-diameter treated pilings (varying in length from 16 to 25 ft) and 3-in. by 8-in. by 12-ft treated boards (Figure 59, longitudinal view). Each piling was braced as shown in Figure 59, lateral view. The boards were bolted to the pilings as shown in Figure 60. The toe of the revetment was protected by a course of stone (Figures 59 and 60). To provide additional mechanical stability for the structure and to prevent formation of a secondary channel, tiebacks were constructed at approximately 75-ft intervals using the same materials as those used for the fence (Figure 61). The resulting structures (Figures 62 and 63) serve as permeable fences. When the bank is attacked by the stream the water velocity is significantly reduced by the fence, thus encouraging sediment deposition which then serves as a substrate for vegetation growth. At the time of both inspection visits, the fences appeared to be structurally sound, and measurable sediment deposition had occurred. The only problem appeared to be failure of the stone foundation at a few points (Figure 64); this failure could conceivably lead to scour around the pilings and failure of the fence.

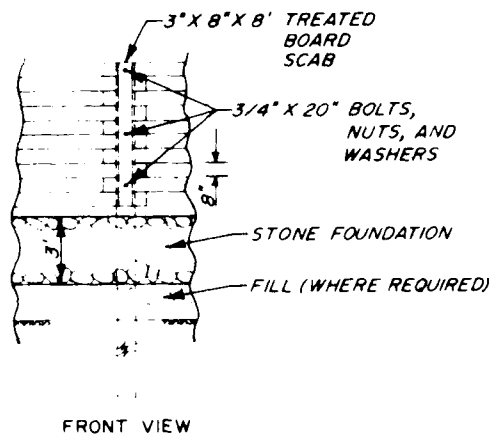
Figure 60. Boards attached to pilings with bolts (Source: Bank Stabilization, Batupan Bogue, Drawing No. 4, LMK, 1977.)

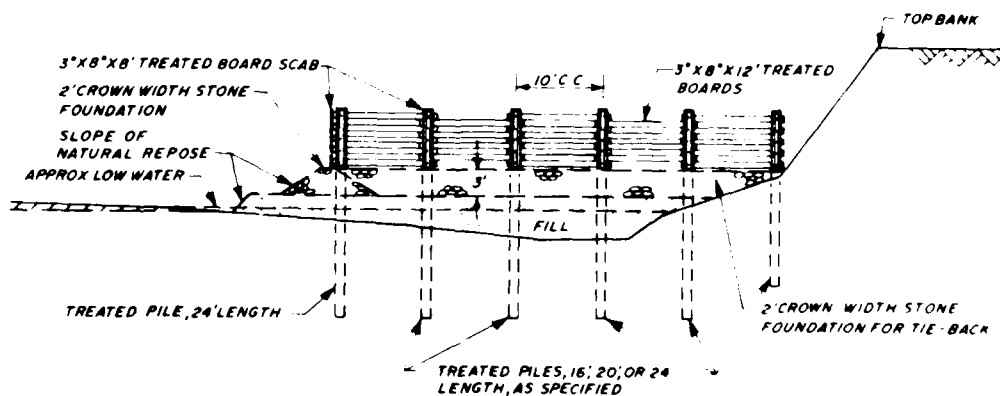
16. The bank protection in Work Area 6 consists of a Type III longitudinal stone dike (Figures 61 and 67); the upper bank will be protected by Type III mulch and willow sprouts. The vegetative treatment had not been placed at the time of the 21 November 1977 storm event; however, the bank had been graded according to project specifications (Table 2). Serious scour occurred on the bank above the stone dike as a result of the storm; the bank has since been paved with riprap at the critical point in the bendway shown in Figure 68.

Figure 61. Tiebacks were constructed at regular intervals to provide additional mechanical stability for the structure and to prevent formation of a secondary channel (Source: Bank Stabilization, Batupan Bogue, Drawing No. 4, LMK, 1977.)

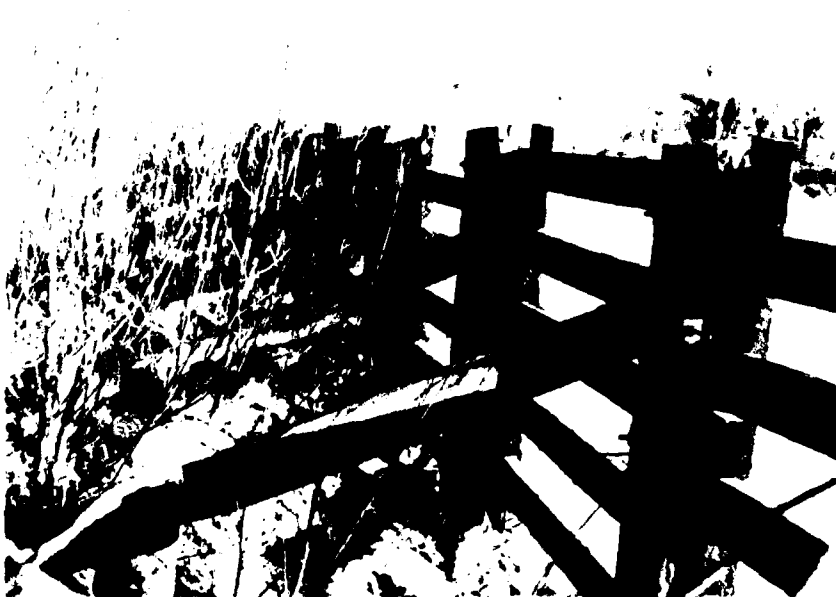
Figure 63. Braces used to support board-fence revetment, Batupan Bogue (25 January 1978)

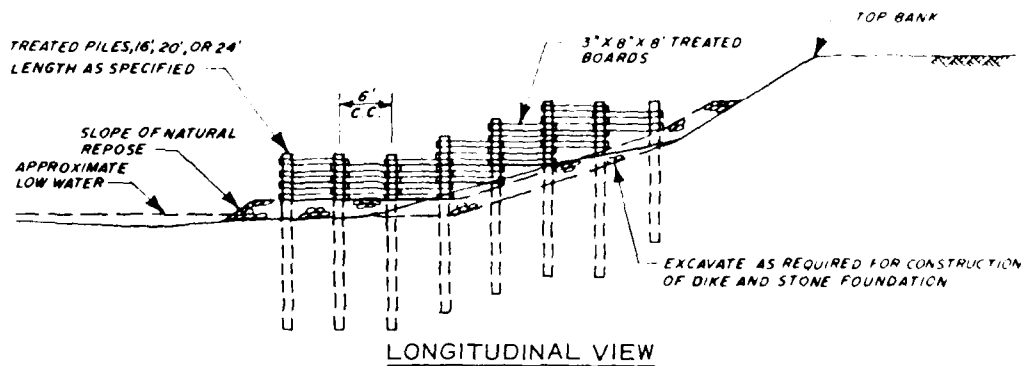
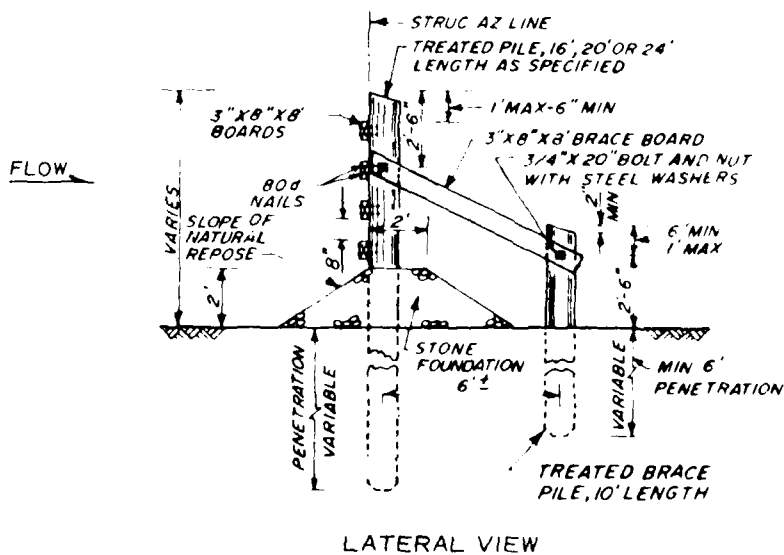
Figure 65. Board-fence dike construction details (Source: Bank Stabilization, Batupan Bogue, Drawing No. 4, L&K, 1972)

32. The board-fence dikes were constructed of 12-in.-diameter treated piles (varying from 16 to 25 ft in length) and 3-in. by 8-in. by 8-ft treated boards (Figure 65, longitudinal view). The dikes were braced laterally by boards nailed to the piling but bolted to a treated brace pile (Figure 65, lateral view). Scour was prevented around pilings by placement of a course of stone riprap (Figure 65). The resulting dikes function as permeable jetties. The velocity of the water flowing through the dikes is reduced, thus encouraging sediment deposition and eventual establishment of vegetation along the bank (Figure 66). In addition to encouraging sediment deposition, the dikes tend to deflect the erosive currents away from the banks toward midchannel. At the date of both inspection visits, very little damage to the dikes was apparent; measurable sediment deposition had occurred. The minor damage noted consisted generally of broken boards, possibly as the result of impact by debris.
